軟弱地盤に建つ公営住宅の不同沈下障害の調査報告

Research Report of Differential Settlement of Public Operated House on the Soft Ground

This is research report on the structural safety of the public operated house which was produced differential settlement.

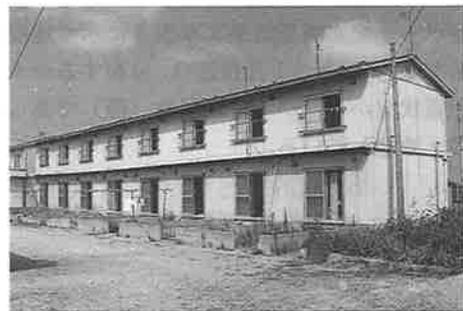
写真1 建物全景(南面)

本建物は昭和46年建設の県営住宅で、構造はPC版組み立て構造2階建、規模は341.92m²である。
